The Proposed Extinguishment of Penleigh Park Level Crossing, Footpath Westbury 15.

Network Rail Response to Objections.

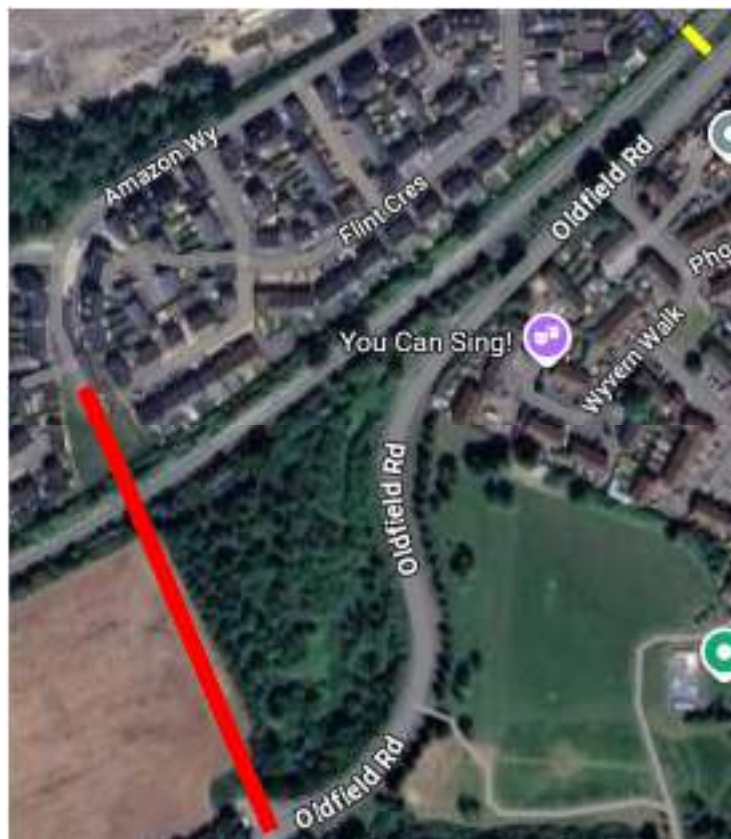
The Council's aspiration at the time was to build a new road bridge across the railway to connect Mane Way to Amazon Way, shown in red below with the crossing in yellow, whereas Network Rail were more concerned about the impact the development would have on level crossing usage and were comfortable should a footbridge be constructed at the

location of the level crossing, location shown in yellow below, this would overcome our safety concerns. Through the planning process and as a requirement of the planning permission for 300 houses in 2016 a £2 million contribution towards the cost of the bridge was required from the developer through a Section 106 agreement.

Wiltshire Council's preference was to construct a new road bridge which at the time was thought to cost in the region of £6-7 million and divert the existing Public Right of Way (PROW) from the level crossing to the new bridge that would facilitate the closure. The remainder of the funding for the bridge would come from a combination of Highway budget and developer contributions from other housing developments being promoted close by in Westbury.

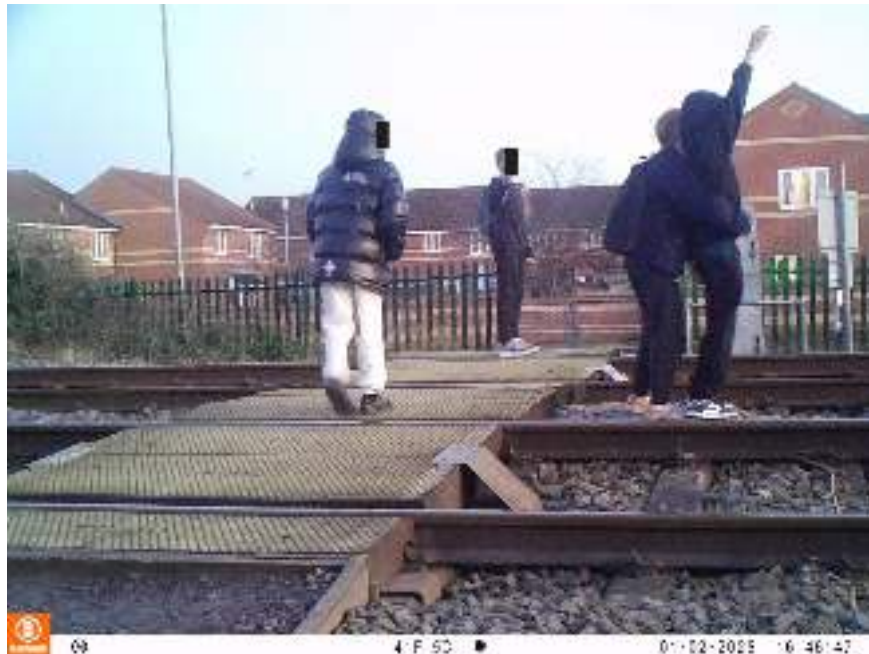
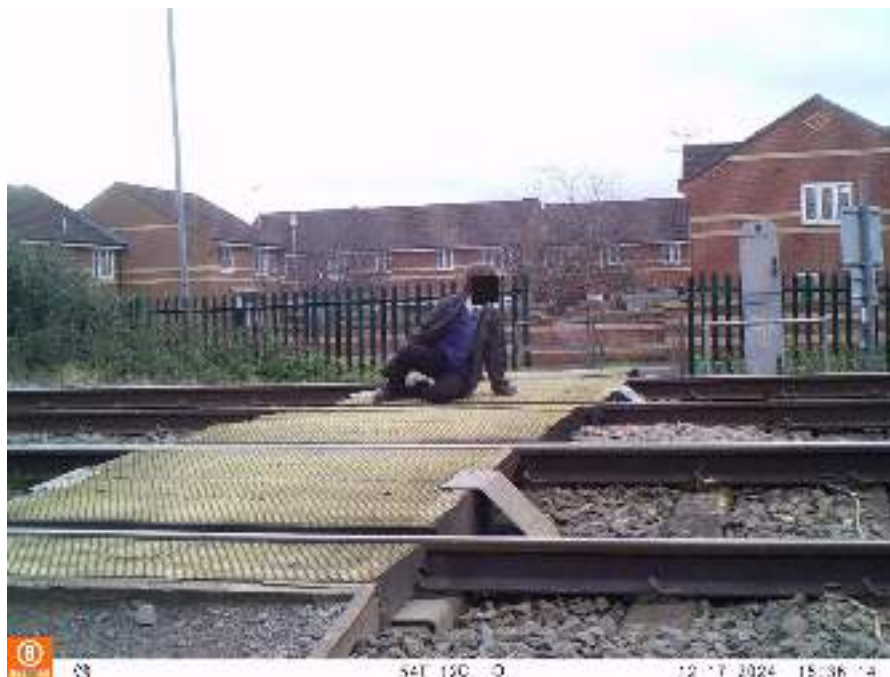
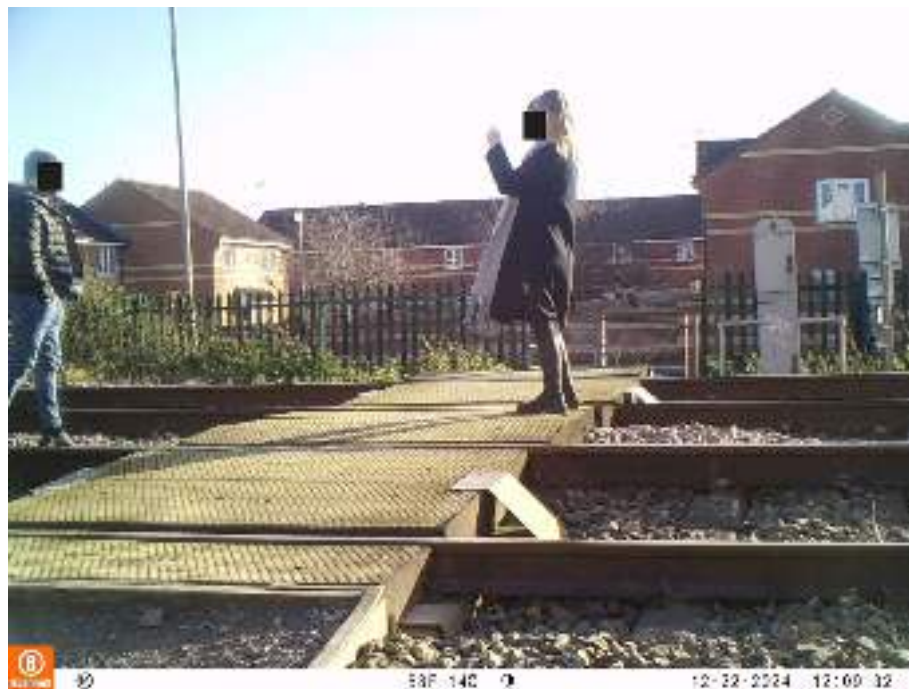
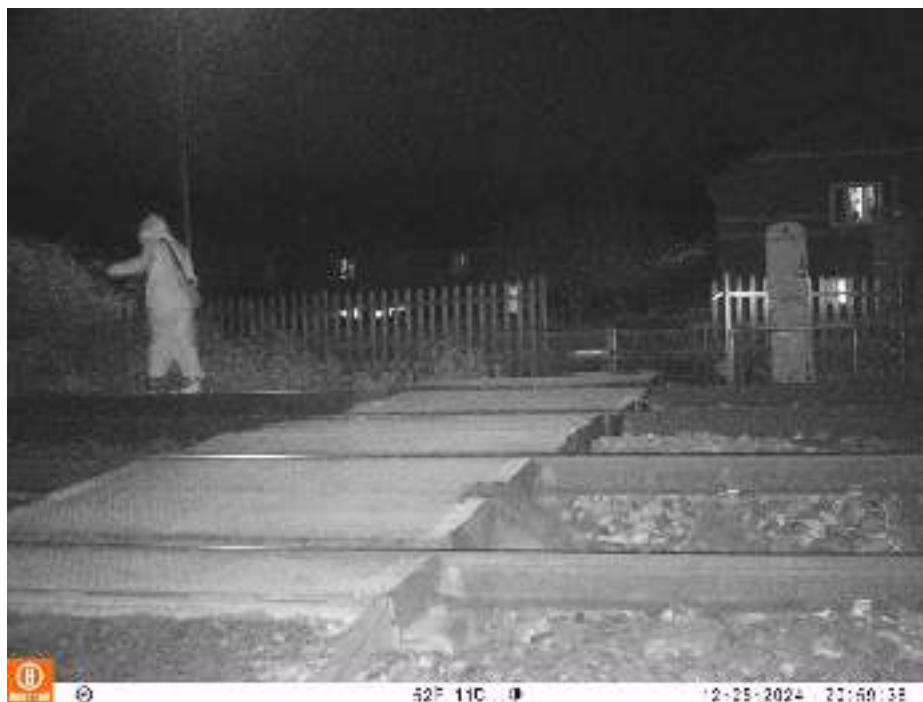
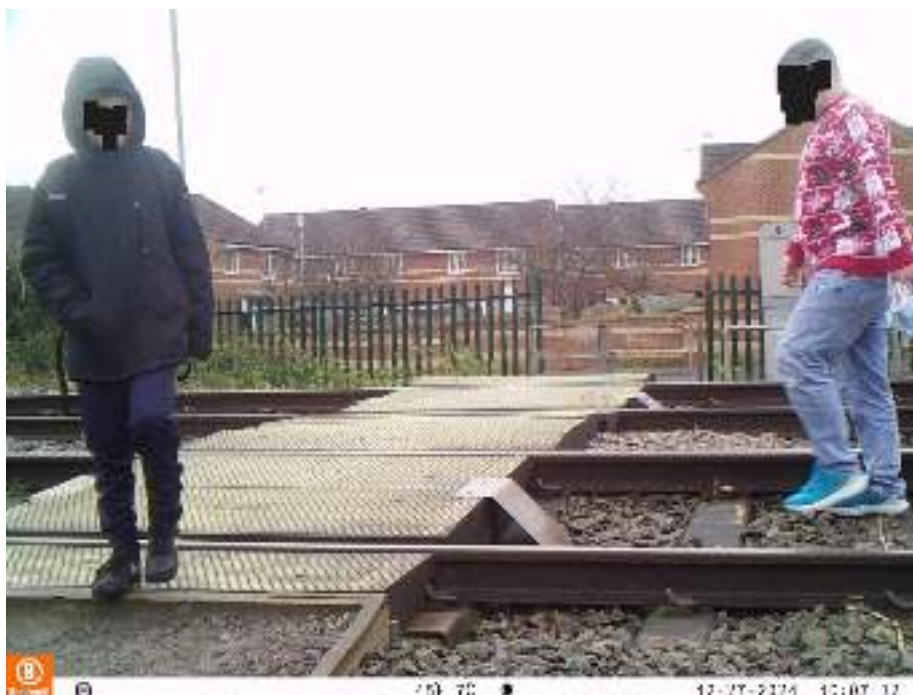
However, although some incidents / misuse goes down as reported there are also occasions of non-reported incidents which are caught on the permanent camera at the crossing, Images below:

In terms of what is meant by misuse, its simply crossing users using the crossing incorrectly and in a way that would cause harm to themselves and possibly others. Examples of this which have been discovered at Penleigh Park LC are as follows:

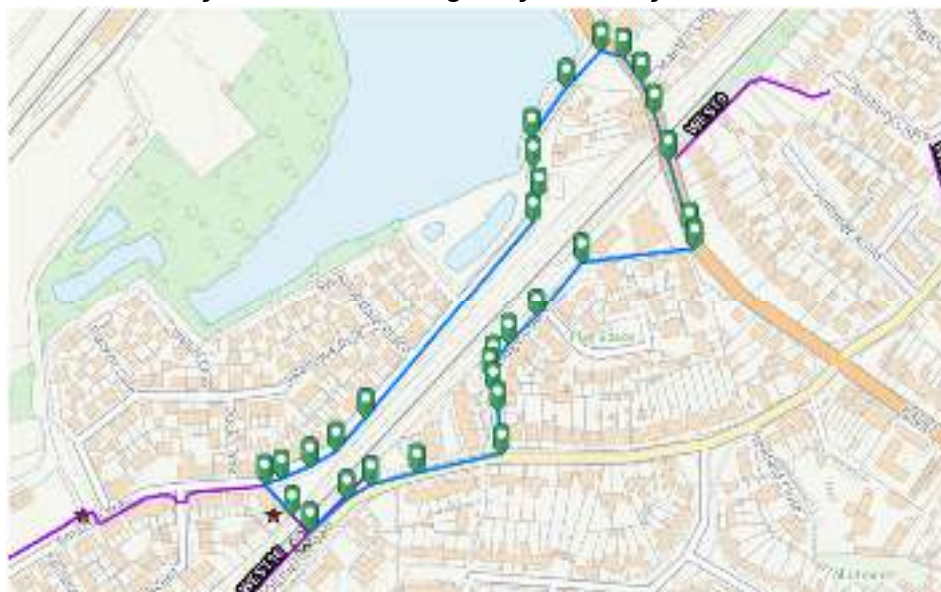
Network Rail acknowledges the alternative route is not ideal given it's 1.3km length from Oldfield Road to Swallows Rise but given the reasons for Level Crossing safety and technology and the lack of alternative bridge being provided above, the alternative route shown below is the only alternative.
